**CRITICAL HABITAT AREAS
OF FENNER LAKE,
ADAMS COUNTY, WISCONSIN
JANUARY 2007**

**Submitted by Reesa Evans
Adams County Land & Water Conservation Department
P.O. Box 287, Friendship, WI 53934
608-339-4268**

CRITICAL HABITAT DESIGNATION For Fenner Lake, Adams County 2006

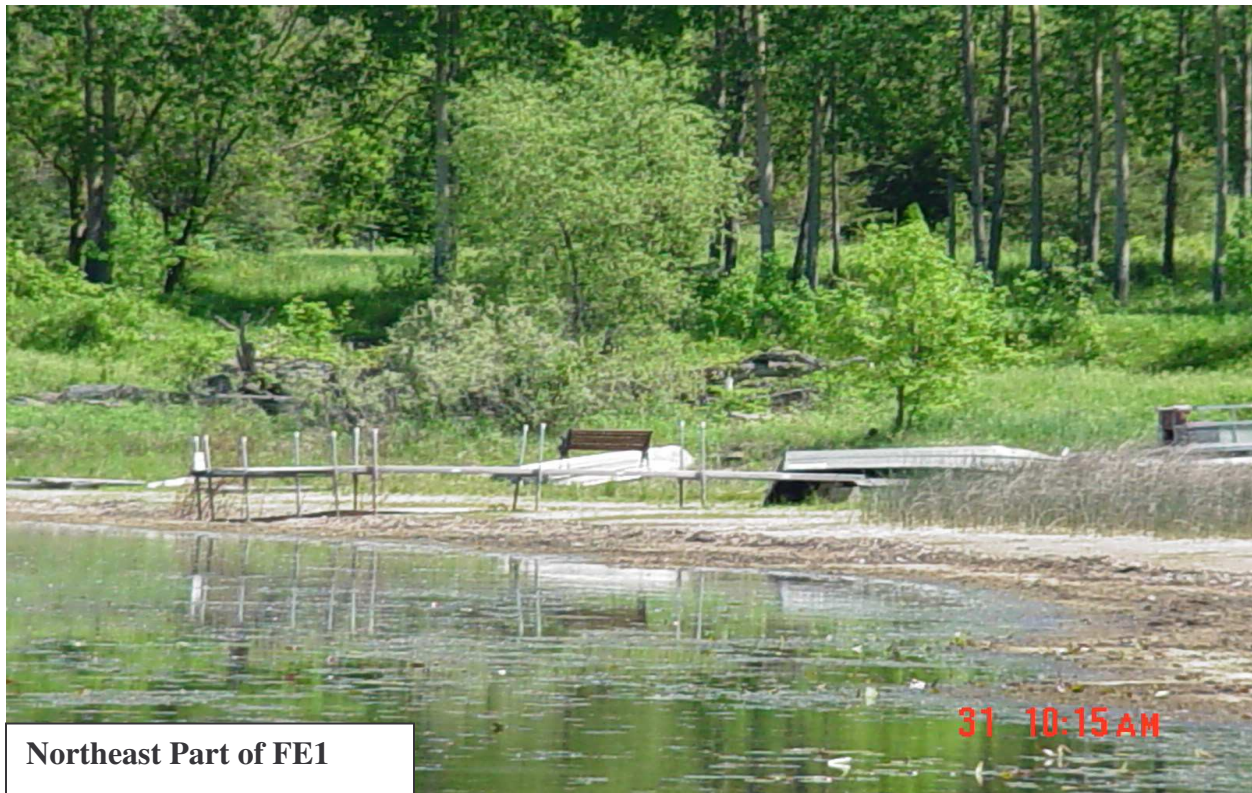
This area extends along approximately 1500 feet of the northeast shoreline, up to the ordinary high water mark and, where there are wetlands, landward of the lake through the wetlands. Sediment includes peat, sand, silt and mixtures thereof. 12.5% of the shore is wooded; 17.5% has shrubs; 47.5% is native herbaceous cover. The balance of the shore in this area includes a small area of cultivated lawn and pavement. Large woody cover is present for habitat. With human disturbance along this shoreline, the area has some natural scenic beauty, although a paved road runs near the area.

Filamentous algae were abundant at this site.

RECOMMENDATIONS FOR AREA FE1

- (1) Maintain current habitat for fish and wildlife.
- (2) Do not remove fallen trees along the shoreline.
- (3) No alteration of littoral zone unless to improve spawning habitat.
- (4) Seasonal protection of spawning habitat.
- (5) Maintain snag/cavity trees for nesting.
- (6) Install nest boxes.
- (7) Maintain or increase wildlife corridor.
- (8) Protect emergent vegetation.
- (9) Minimize aquatic plant and shore plant removal to maximum 30' wide viewing/access corridor. Leave as much vegetation as possible to protect water quality and habitat.
- (10) Seasonal control of Curly-Leaf Pondweed and, if necessary, Eurasian Watermilfoil, using control methods selective for exotics.

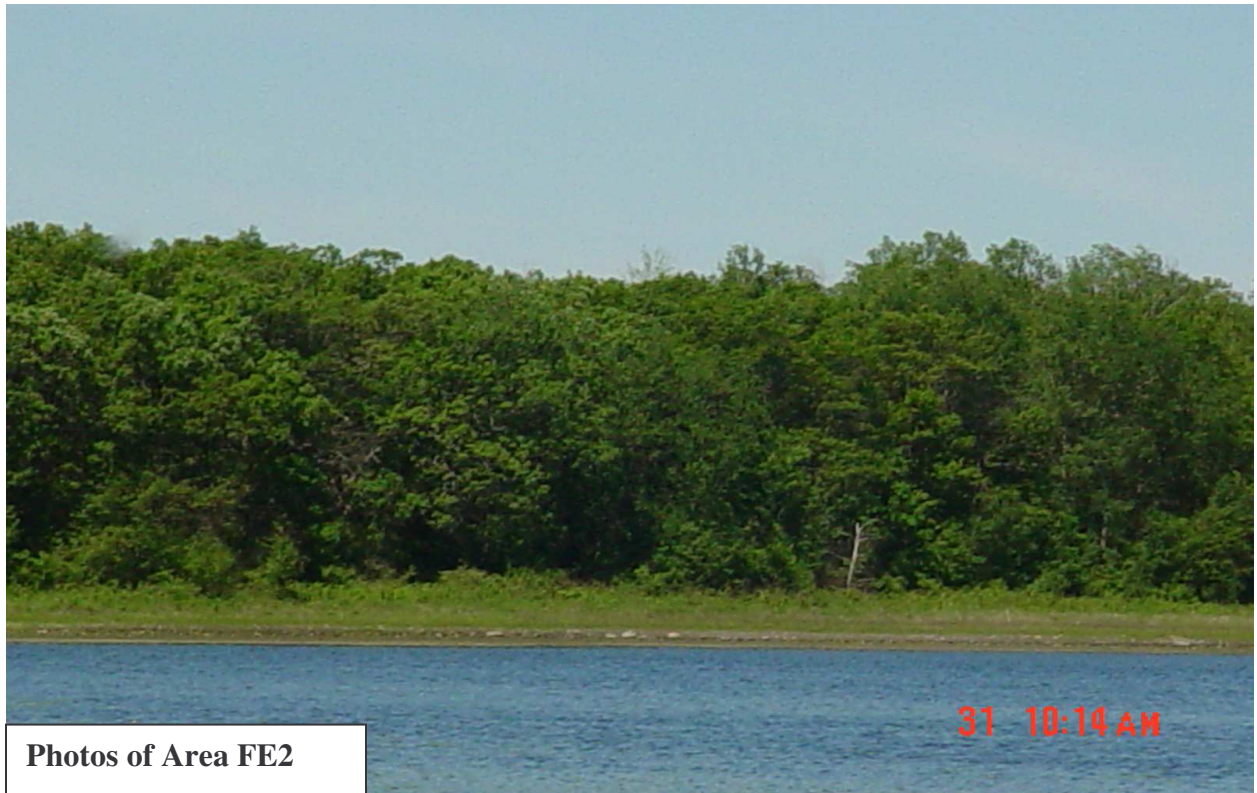
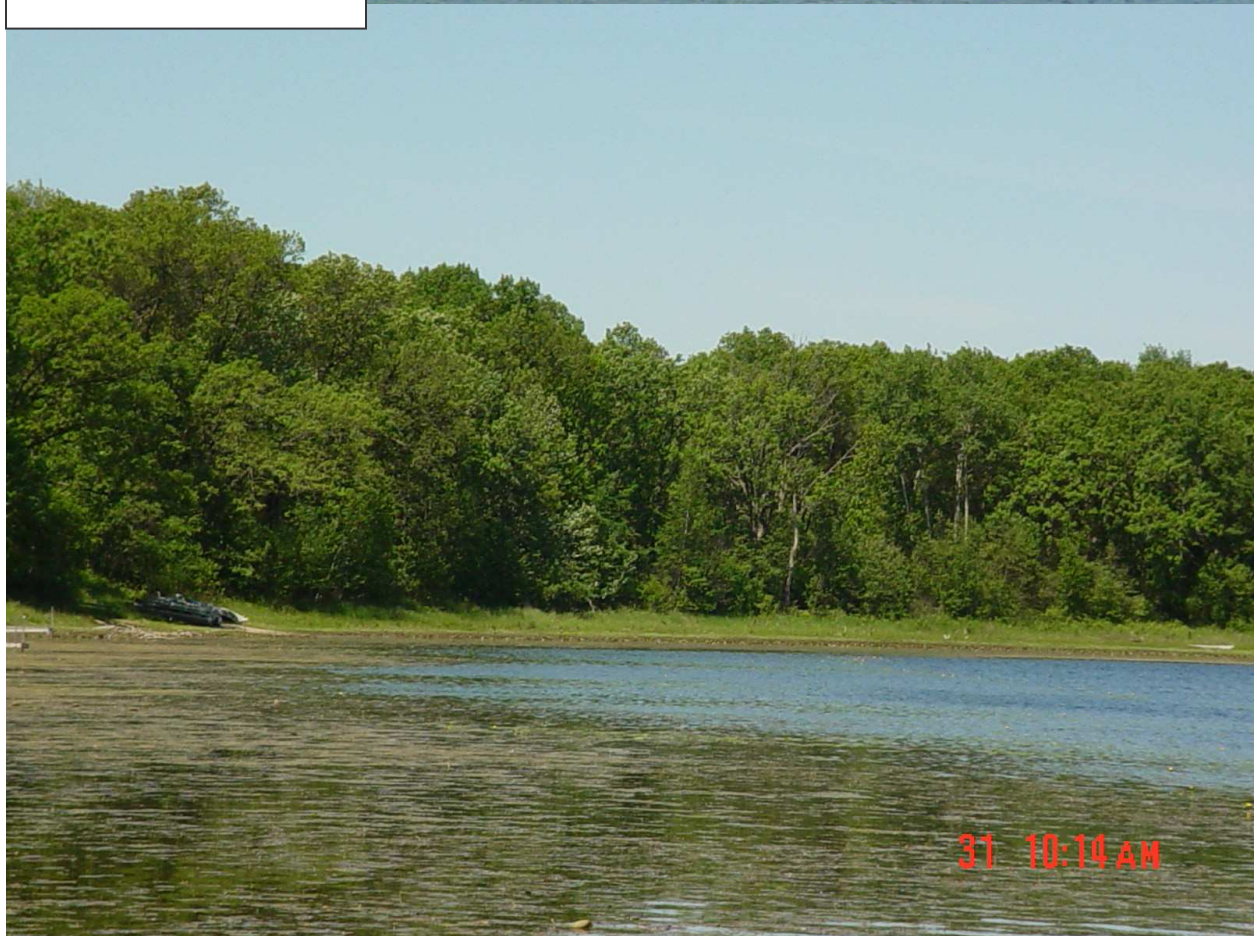
Photos of Area FE2

This area extends along approximately 2500 feet along the southwest shoreline. Sediment includes muck, peat, sand, silt and mixtures thereof. 22.5% of the shore is wooded; 7.5% has shrubs; and 61.25% is native herbaceous cover. The remaining shore in this area is cultivated lawn and hard structure. Large woody cover is present. With minimal human disturbance along this shore, the area is has natural scenic beauty.

RECOMMENDATIONS FOR FE2

- (1) Maintain current habitat for fish and wildlife.
- (2) Do not remove fallen trees along the shoreline nor logs in the water.
- (3) No alteration of littoral zone unless to improve spawning habitat.

- (4) Seasonal protection of spawning habitat.
- (5) Maintain snag/cavity trees for nesting.
- (6) Maintain or increase wildlife corridor.
- (7) Install nest boxes.

- (8) Protect emergent vegetation for habitat and shoreline protection.
- (9) Removal of submergent vegetation for navigation purposes only.
- (10) Seasonal control of Curly-Leaf Pondweed and, if necessary, of Eurasian Watermilfoil, using methods specific for control of exotics.

- (11) Minimize aquatic plant and shore plant removal to maximum 30' wide access/viewing corridor. Leave as much vegetation as possible to protect water quality and habitat.

- (12) Use forestry best management practices.
- (13) Consider purchase of conservation easement to prevent future development of this area.
- (14) No use of lawn products.

- (15) No bank grading or grading of adjacent land.

- (16) No pier construction or other activity except by permit using a case-by-case evaluation.
- (17) No installation of pea gravel or sand blankets.
- (18) No bank restoration unless the erosion index scores moderate or high.
- (19) If the erosion index does score moderate or high, bank restoration only using biologists or similar bioengineering, with no use of riprap or retaining walls, and must include a stormwater management component.
- (20) Placement of swimming rafts or other recreational floating devices only by permit.
- (21) Maintain buffer of shoreline vegetation.
- (22) Maintain aquatic vegetation buffer in undisturbed condition for wildlife habitat, fish use and water quality protection.
- (23) Post landing with exotic species alert and educational signs to prevent introduction and/or spread of exotic species.
- (24) Maintain no-motor designation of lake.

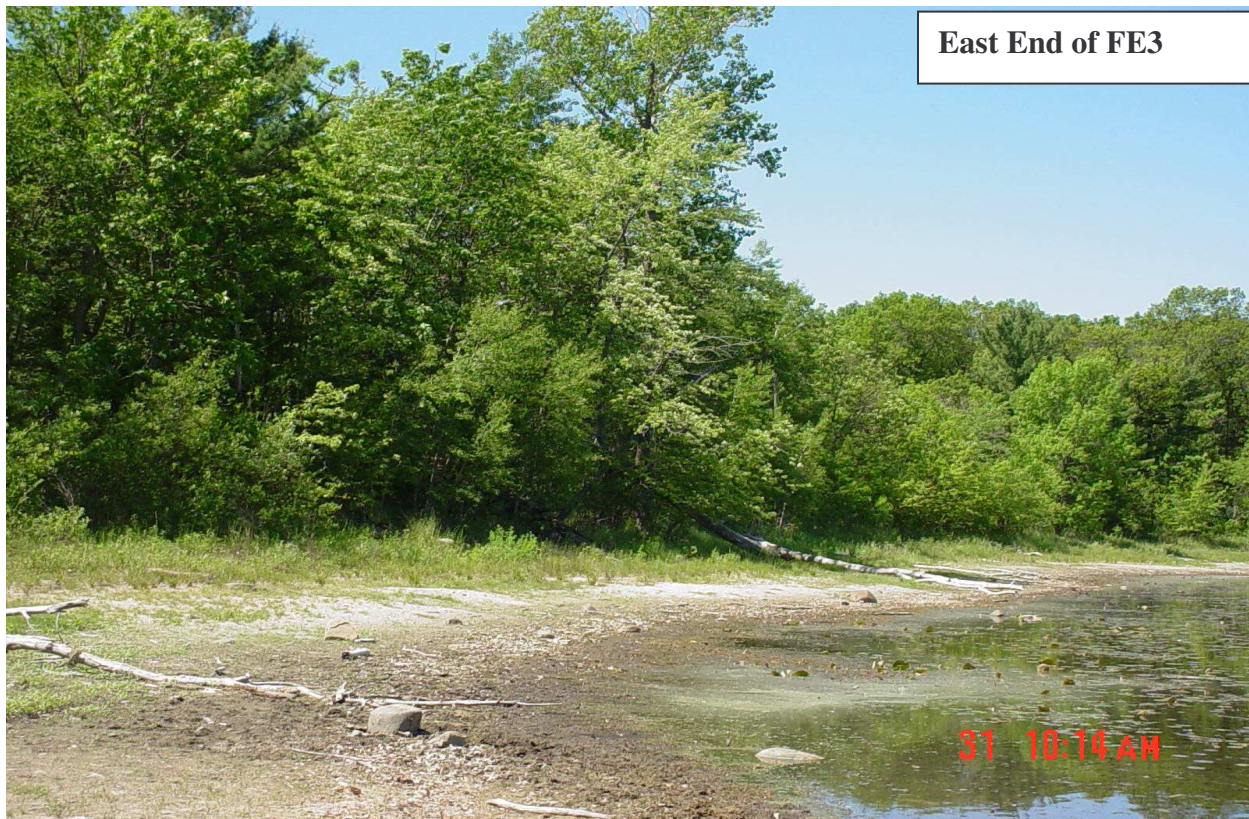
East End of FE3

This area extends along approximately 450 feet of the southeast shoreline. Sediment includes gravel, peat, sand, and mixtures thereof. 32.5% of the shore is wooded; 12.5% has shrubs; 32.5% is native herbaceous cover—the remaining is bare sand. Large woody cover is common. Scenic beauty in part of the area is lessened due to the human development, especially the proximity of the sand boat ramp area.

RECOMMENDATIONS FOR FE3

- (1) Maintain current habitat for fish and wildlife.
- (2) Do not remove fallen trees along the shoreline nor logs in the water.
- (3) No alteration of littoral zone unless to improve spawning habitat.

- (4) Seasonal protection of spawning habitat.
- (5) Maintain snag/cavity trees for nesting.
- (6) Maintain or increase wildlife corridor.
- (7) Install nest boxes.

- (8) Protect and, if possible, enhance emergent vegetation for habitat and shoreline protection.
- (9) Removal of submergent vegetation for navigation purposes only.

- (10) Seasonal control of Curly-Leaf Pondweed and, if necessary, of Eurasian Watermilfoil, using controls selective for exotics.
- (11) Minimize aquatic plant and shore plant removal to maximum 30' wide access/viewing corridor. Leave as much vegetation as possible to protect water quality and habitat.
